PRESERVATION BRIEFS

29

The Repair, Replacement and Maintenance of Historic Slate Roofs

Jeffrey S. Levine

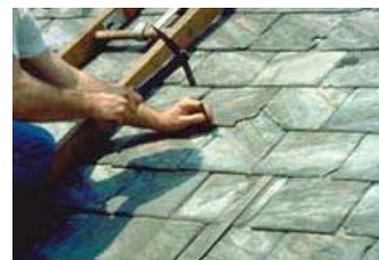
Slate roof repair. Photo: Jeffrey S. Levine.

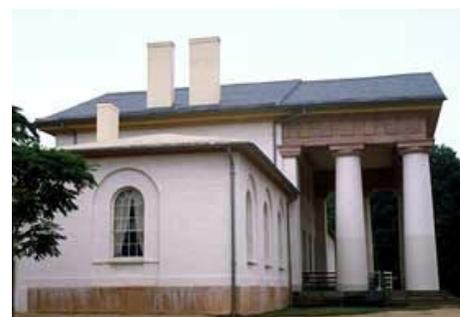
Although slate replacement roofs are expensive, the superiority of materials and craftsmanship will give years of continued service. If amortized over the life of the roof, the replacement cost can be very reasonable. Photo: NPS files.

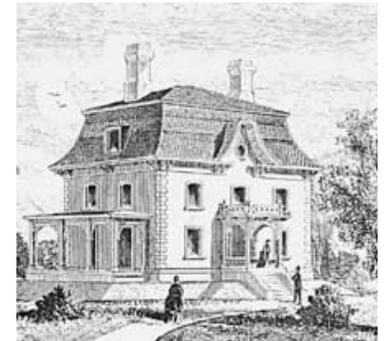
Architectural pattern books of the mid-19th century awakened Americans to the availability and quality of slate for roofing purposes. Drawing: Design XX, "A French Roof House," in A.J. Downing's *Victorian Cottage Residences*.

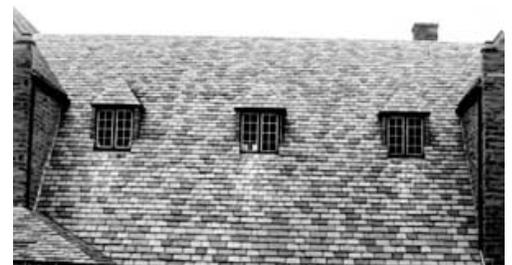
This graduated slate roof is composed of large, thick slates

at the eave which are reduced in size and thickness as the slating progresses to the ridge. Photo: Jeffrey S. Levine.

Graduated slate roofs were frequently installed on large institutional and ecclesiastical structures. The slates were graduated according to thickness, size, and exposure, the thickest and largest slates being laid at the eaves and the thinnest and smallest at the ridge. Pleasing architectural effects were achieved by blending sizes and colors.

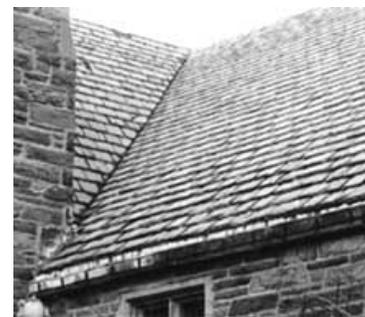
Valleys are formed at the internal angle of two roofing slopes. Flashing is often placed under the slate to increase moisture protection at this vulnerable joint. Photo: Jeffrey S. Levine.

Two types of valleys were traditionally employed, the **open valley** and the **closed valley**. The open valley is lined with metal over which slates lap only at the sides. Closed valleys are covered with slate and have either a continuous metal lining or metal flashing built in with each course. Open valleys are easier to install and maintain, and are generally more watertight than closed valleys. Round valleys are a type of closed valley with a concave rather than Vshaped section. Given the broader sweep of the round valley, it was not uncommon for roofers to interweave asphalt saturated felts rather than copper sheet in the coursing in order to cut costs.

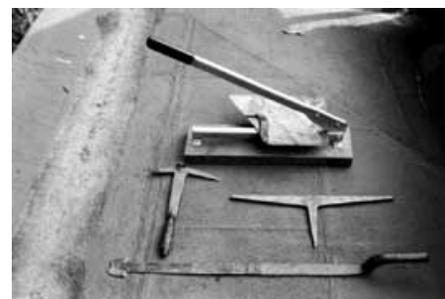
These traditional slater's tools are used to cut and trim, hammer, measure, and rip out nails. Photo: Jeffrey S. Levine.

Slate roofing tiles are still manufactured by hand using traditional methods in a five step process: **cutting, sculping, splitting, trimming, and hole punching**. In the manufacturing process, large, irregular blocks taken from the quarry are first cut with a saw across the grain in sections slightly longer than the length of the finished roofing slate. The blocks are next sculped, or split along the grain of the slate, to widths slightly larger than the widths of finished slates. Sculping is generally accomplished with a mallet and a broadfaced chisel, although some types of slate must be cut along their grain. In the splitting area, the slightly oversized blocks are split along their cleavage planes to the desired shingle thickness. The splitter's tools consist of a wooden mallet and two splitting chisels used for prying the block into halves and repeating this process until the desired thinness is reached. The last two steps involve trimming the tile to the desired size and then punching two nail holes toward the top of the slate using a formula based on the size and exposure of the slate.

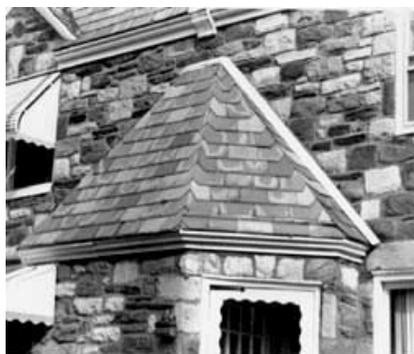
The white blotches on these Pennsylvania Soft-Vein slates indicate areas where gypsum is leaching out onto the surfaces of the slates. Photo: Jeffrey S. Levine.

The weathering of slate is chiefly due to mineral impurities (primarily calcite and iron sulfides) in the slate which, in concert with alternating wet/dry and hot/cold cycles, react to form gypsum. Because gypsum molecules take up about twice as much volume as calcite molecules, internal stresses result from the reaction, causing the slate to

delaminate. This type of deterioration is as prominent on the underside of the roof as on the exposed surface due to the leaching and subsequent concentration of gypsum in this area. Consequently, deteriorated roofing slates typically cannot be flipped over and reused.

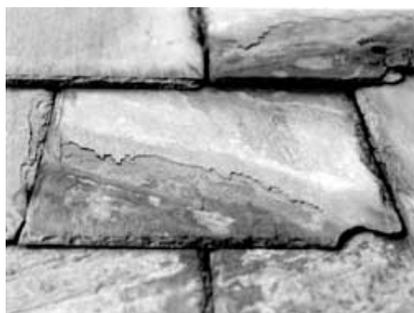
Paper thin lamination can be seen flaking off this weathered, 120 year piece of Pennsylvania Hard-Vein slate. Photo: Jeffrey S. Levine.

The natural weathering of roofing slate manifests itself as a slow process of chipping and scaling along the cleavage planes. Paper thin laminations flake off the surface of the slate and the slate becomes soft and spongy as the inner layers begin to come apart, or delaminate. The nature of the sound given off by a slate when tapped with one's knuckles or slating hammer is a fair indication of its condition. Highgrade slate, when poised upon the fingertips and struck, will emit a clear, solid sound. Severely weathered slates are much less sonorous, and give off a dull thud when tapped.

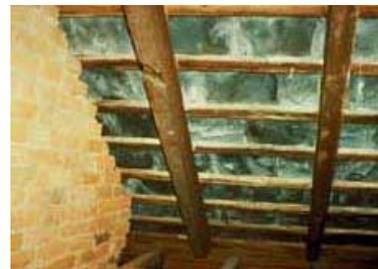
View of these slates laid on open sheathing shows that delamination and flaking are just as bad or worse on the underside of slates as on the exposed surface. This is why most slates cannot be flipped over for reuse.
Photo: Jeffrey S. Levine.

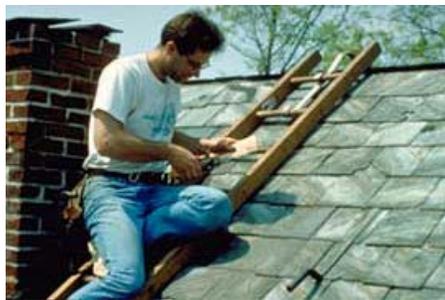
After removing the deteriorated slate and sliding the new slate into place, it is secured with a copper nail. A copper bib (shown here) is formed to protect the newly created nail hole. Finally, a slate hammer is used to push the bib in place over the nail head.

To prevent water penetration through the newly created nail hole, a piece of copper with a friction fit, measuring roughly 3" (7.5 cm) in width and 8" (20 cm) in length, is slid lengthwise under the joint between the two slates located directly above the new slate and over the nail. Alternate methods for securing the replacement slate include the use of metal hooks, clips, and straps that are bent over the tail end of the slate. The application of roofing mastic or sealants to damaged slates should not be considered a viable repair alternative because these materials, though effective at first, will eventually harden and crack, thereby allowing water to enter. Mastic also makes future repairs more difficult to execute, is unsightly, and, when applied to metal flashings, accelerates their corrosion.

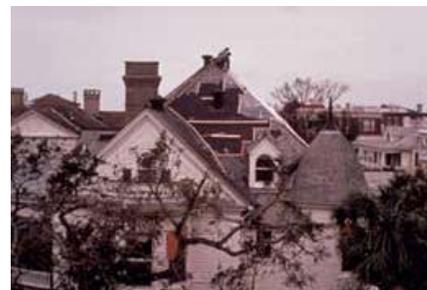
After a hurricane or other natural disaster, it may be necessary to stabilize a roof temporarily until materials can be obtained and a qualified roofing contractor hired. Significant slate roofs should not be stripped off and replaced with asphalt shingles. Photo: NPS files.

In emergency situations, such as when severe hurricanes or tornadoes blow numerous slates off the roof, a temporary roof covering should be installed immediately after the storm to prevent further water damage to the interior of the building and to permit the drying out process to begin. Heavy gauge plastic and vinyl tarpaulins are often used for this purpose, though they are difficult to secure in place and can be blown off in high winds. Roll roofing, carefully stitched in to areas of the remaining roof, is a somewhat more functional solution that will allow sufficient time to document the existing roof conditions, plan repairs, and order materials.

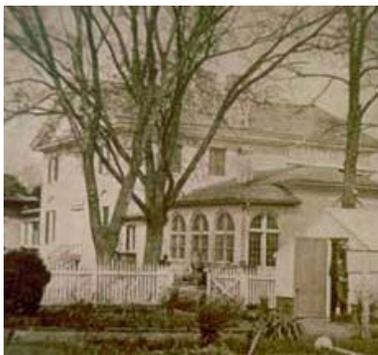
Prior to a replacing a roof, historical documentation is gathered (such as photo documentation) to determine the roof configuration. Photo: NPS files.

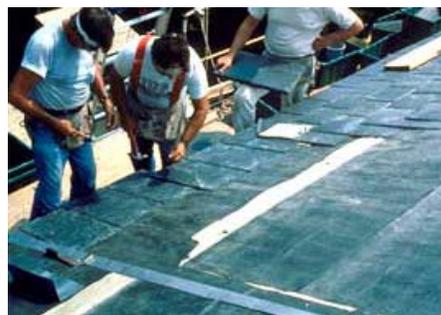
Roofing felt is being installed over the decking; a rubberized membrane is used selectively at the eaves and under some flashing. Photo: NPS files.
