# FORM B - Building

2 Bixby Hill Road

Former Christian Union Parsonage

#### **BUILDING FORM**

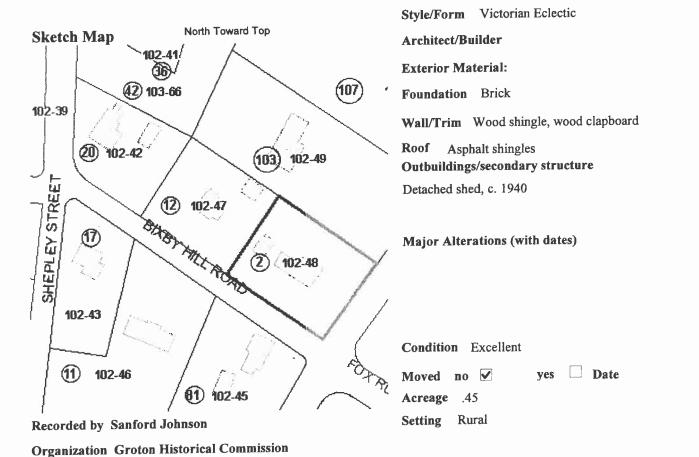
- \* The Victorian Eclectic style house at 2 Bixby Hill Road is a front-gabled, 2 1/2-story, 2x2-bay form with a 1-story ell attached to the west elevation

- \* The corner entry, recessed in a cutaway porch, is covered by a semi-circular hood supported by Doric columns; a secondary porch covers the south elevation of the ell and is supported by posts with jigsawn brackets; a small rectangular bay window of 1 story projects from the south elevation of the main block

- \* Architectural detail includes the 3 courses of stagger-butt shingles at the second story and in two levels in the gable peaks, the flared course of shingles that divides the first story from the second, and the molded cornice which appears at the soffit that divides the second story from the gable

- \* Windows are mainly 1/1 double hung sash with some 2/2 examples in varied locations; window trim is plain except around the gable peak window which has the upper soffit as a hood and three small brackets below

- \* The corner entrance has plain trim
- \* The detached shed may have once functioned as a garage and is clad in wood shingles
- \* The house is well-maintained and appears to retain most original materials and design features
