FORM B - Building

96 Hollis Street

BUILDING FORM

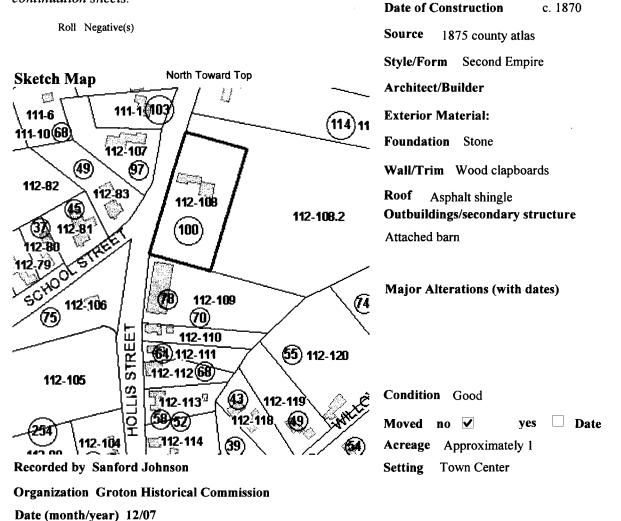
* The house at 96 Hollis Street (also listed on the town website as #100) is a Second Empire style, 2 1/2-story, 3x4-bay form with a rear ell and attached barn; the upper section of the roof is a ridge-hipped form; the lower pitch of the Mansard roof has a straight pitch with flared lower course

* Decorative features are the corner boards and molded cornices at the eave and at the junction of the two roof slopes

* Windows are mainly 6/6 double-hung sash with 2/2 units in the upper story; window trim is plain other than the pedimented hoods over the 2 dormers in the Mansard section of the façade; the bay above the side hall entry is unfenestrated

* The side-hall entry has classical trim including pilasters and pedimented hood above; small brackets at the cornice and sidelights also exist

* 2 brick chimneys rise from the southern elevation and flank a dormer containing paired double-hung sash

* The rear ell is composed of a 2-story gabled section against the rear of the house and a 1 1/2-story gabled block connecting to the barn

* The barn has a Mansard roof to match the house; access is through a rolling vehicle door; additional openings in the principal elevation contain a fixed 12-pane sash, pedestrian door and paired double-hung sash in the lower slope of the Mansard roof set under a pedimented hood; siding is wood clapboard

- * One open porch and one enclosed porch exist at the junction of the house and barn
- * The house is in good condition and is very similar in form, design and scale to those at 97 and 111 Hollis Street
