## **FORM B - Building**

**Organization Groton Historical Commission** Date (month/year) 12/07

\* The house at 36 Willowdale Road is a cross-gabled, 2 1/2-story wood clapboard building of 3 bays' depth on the southwest elevation and 2 on the northeast; the façade is an asymmetrical 3-bay design with three windows lighting the second story, two windows and paired entry doors filling the first story openings and a gable peak window above; A shed-roofed porch covers the center entry; A two-story bay window and the cross gable project from the southwest elevation

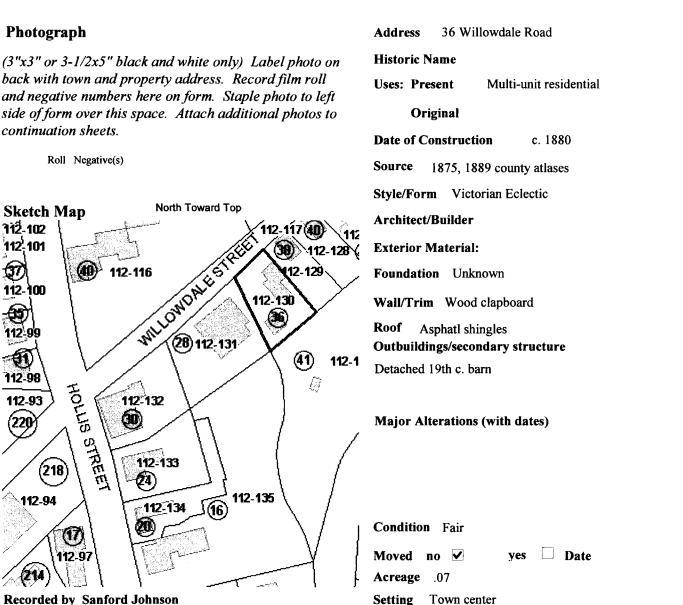
\* Decorative elements include the molded cornice, corner boards, gable returns and turned posts with carved brackets supporting the entry porch and its simple cornice,

\* Windows are 2/2 double-hung sash with flat trim

\* The paired entries appear to be original, have matching doors with three panels and four lights

\* The detached barn is a front-gabled form with a vehicle door, mow door and unfenestrated window opening in the principal elevation; Ornament includes the gable returns, molded cornice and corner boards that match those elements on the house; This is one of around two dozen barns in Groton Center

\* The building is set on a flat parcel in a residential neighborhood and remains in fair condition with its exterior features intact
