FORM B - Building

Address 79 Schoolhouse Road
Historic Name Gale House
Uses: Present Residential/agricultural
Original Residential/agricultural
Date of Construction c. 1890
Source Estimate

Style/Form Victorian Eclectic

Groton
79 Schoolhouse Road

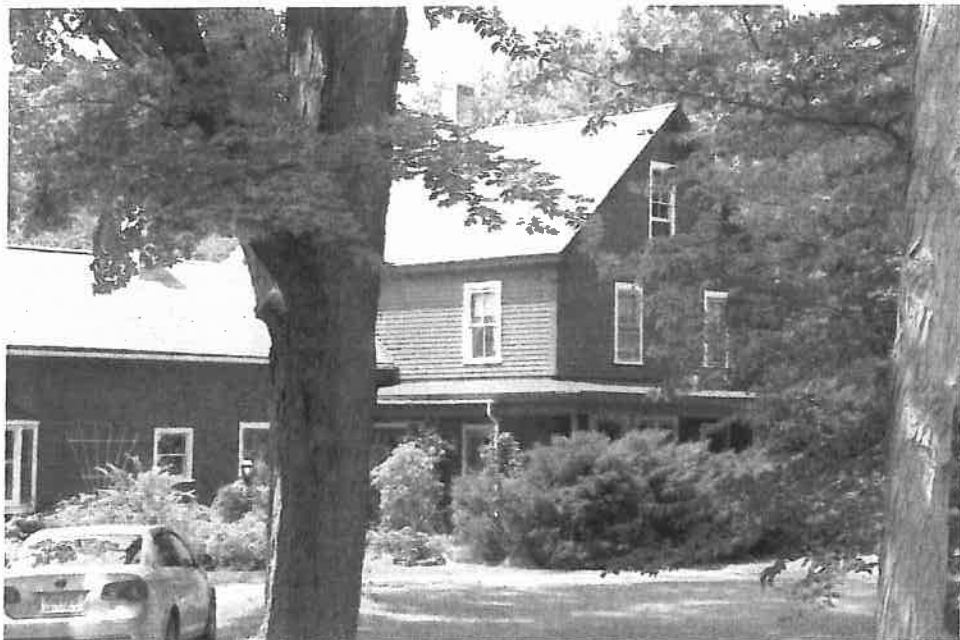
79 Schoolhouse Rd

- * The Victorian Eclectic style farmhouse at 79 Schoolhouse Road is a front-gabled, 2x2-bay, 2 1/2-story form with a 1-story ell at the south side that connects to the front-gabled barn; a 1-story open porch covers the first story of the façade and the south elevation of the main block

- * Decorative features include the corner pilasters with molded caps, gable returns and molded cornice
- * Windows are 2/2 double hung sash with plain trim

- * The house and barn are well-maintained, occupy a rural setting and are typical in terms of scale and details for Groton farms; the barn continues to house horses

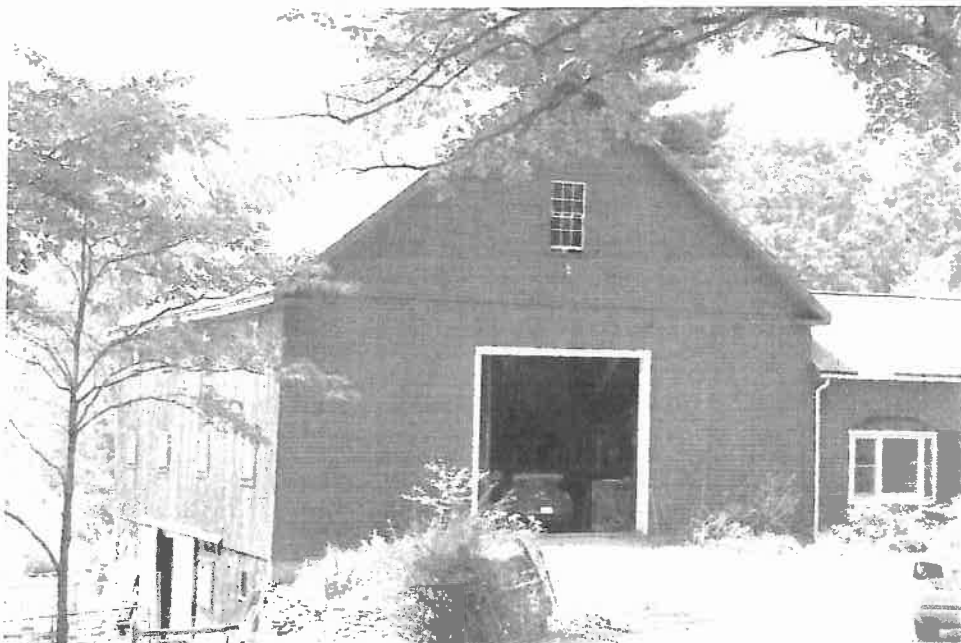
79 Schoolhouse Rd

- * The barn is banked with the south side of the foundation open at the ground level; the façade has a rolling vehicle door in the center and a single 6/6 sash in the gable peak; additional window openings have fixed 6-pane sash on the south elevation at both the first and second stories; decorative features are the gable returns that match those on the house and corner boards
